Insight Infrared Energy Inspections Inc. was retained by Ms. Lori McLeod, to perform an Infrared scanning survey of the existing test building located in Winnipeg, MB.

Project: U of M

Date: February, 2003

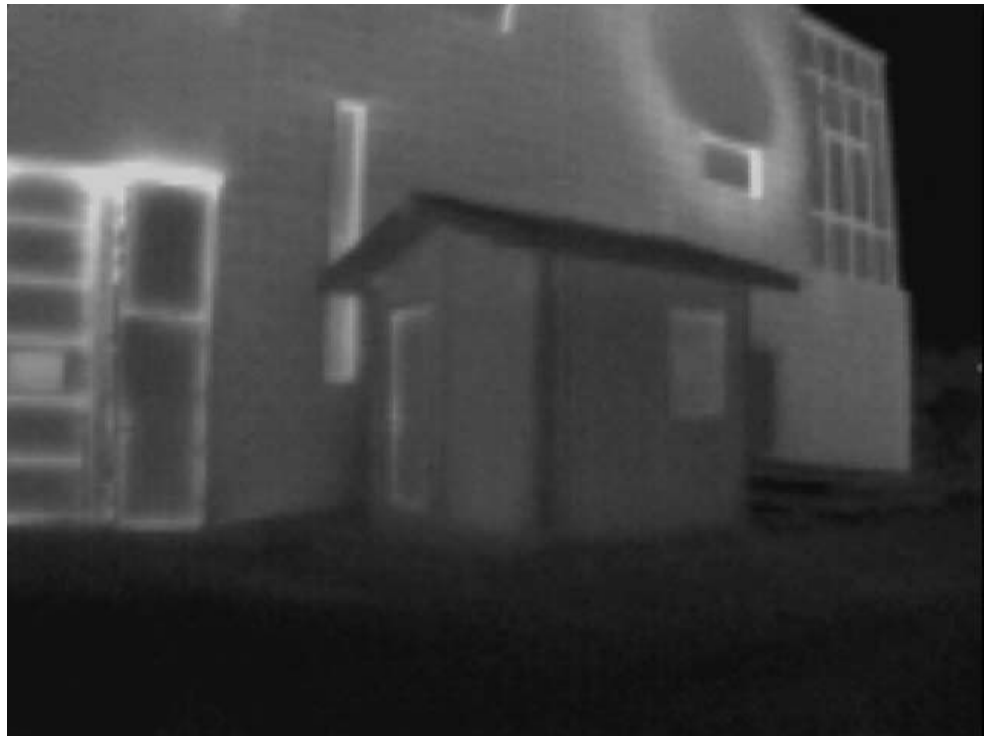
Photo # 1

Picture of the small test building.

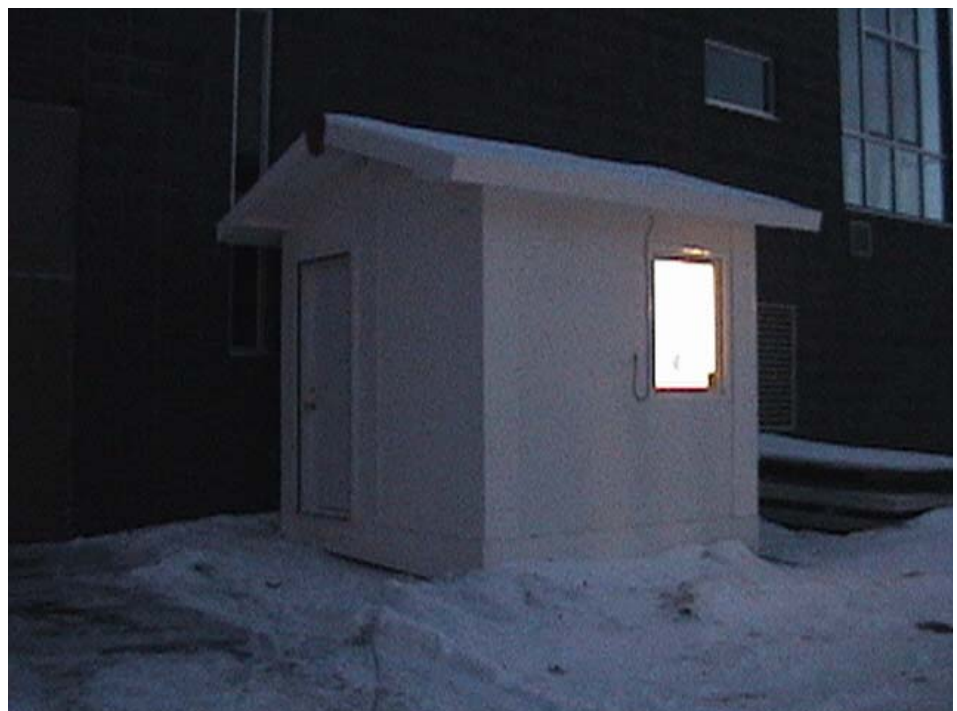
Photo # 2

Real Life photograph of the test building.

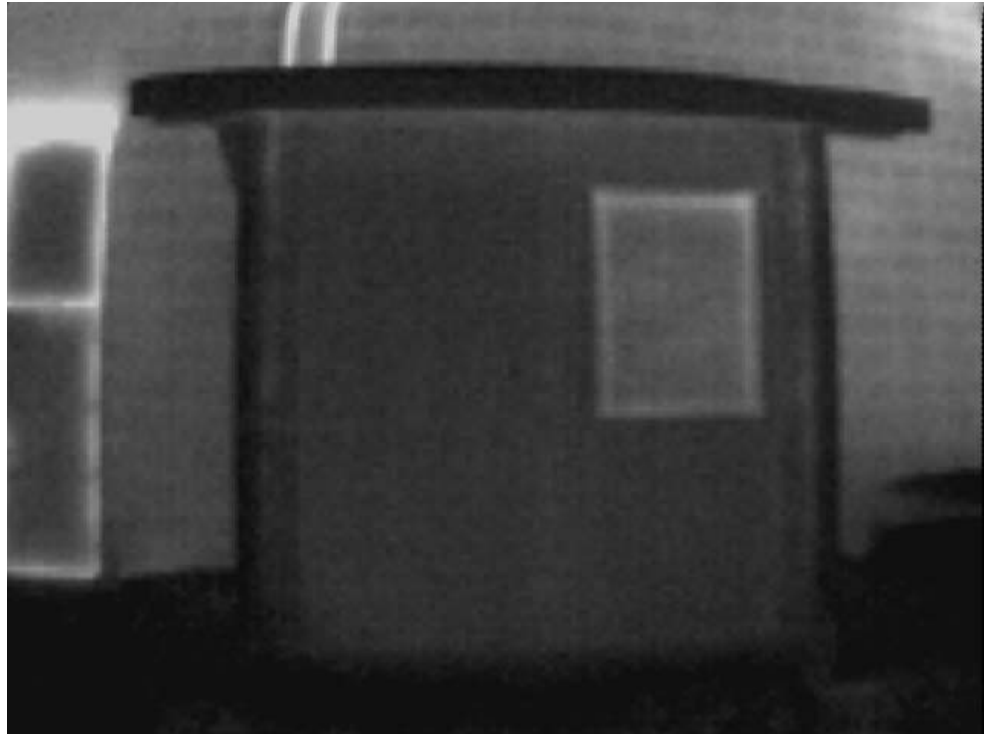
Photo # 3

Picture of the North wall,
please note no heat loss
was noted at the time of
this survey.

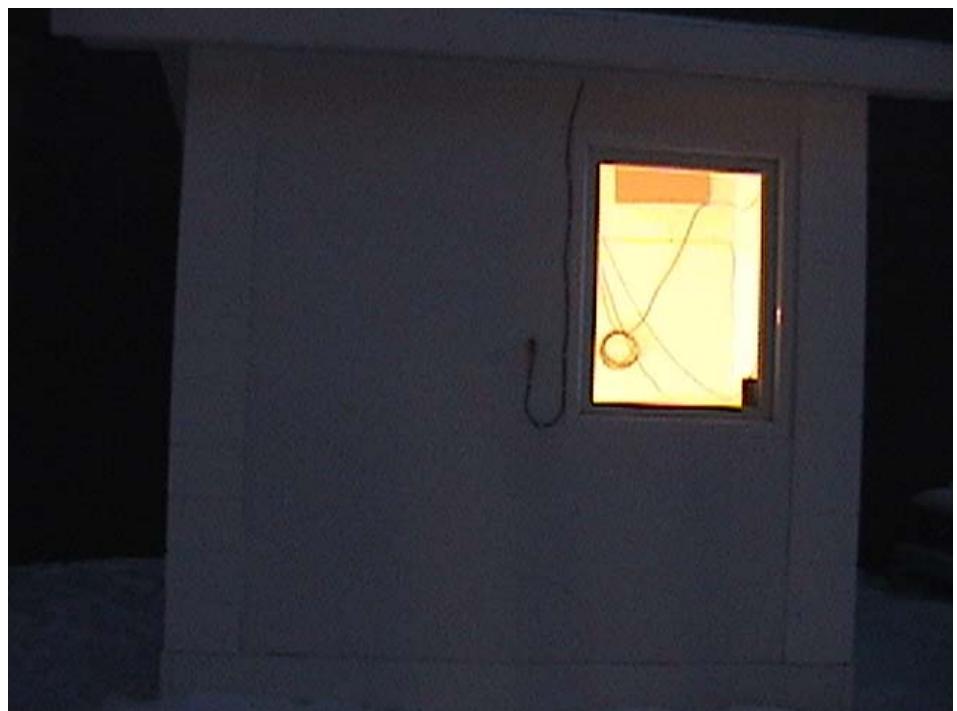
Photo # 4

Real Life photograph of the
test building.

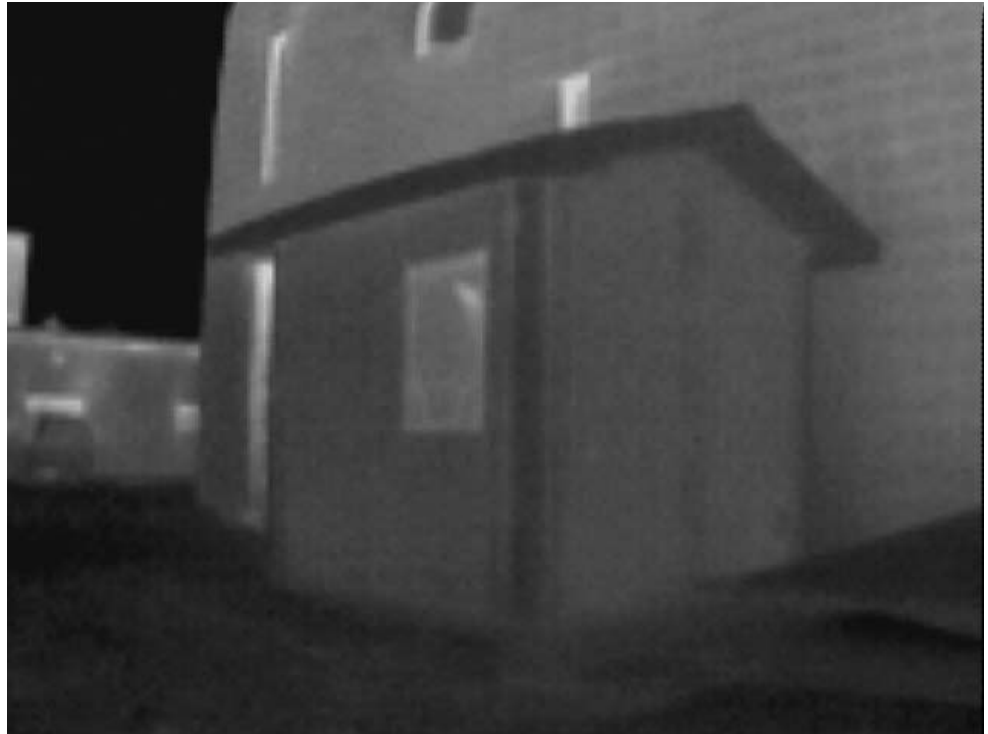
Photo # 5

Picture of the North and West walls of the test building.

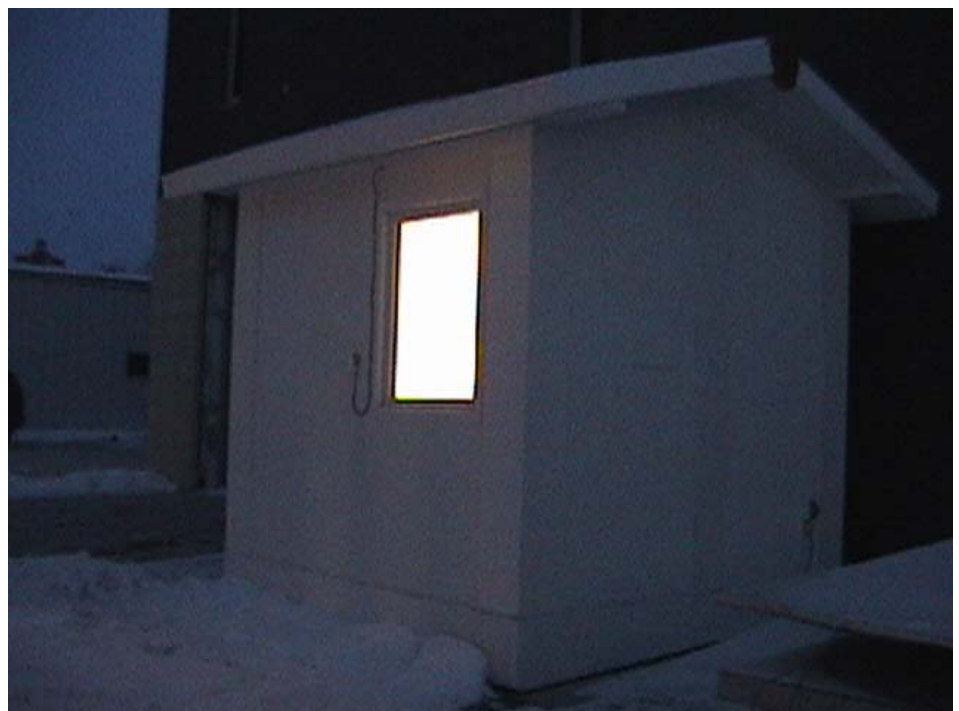
Photo # 6

Real Life photograph of the test building.

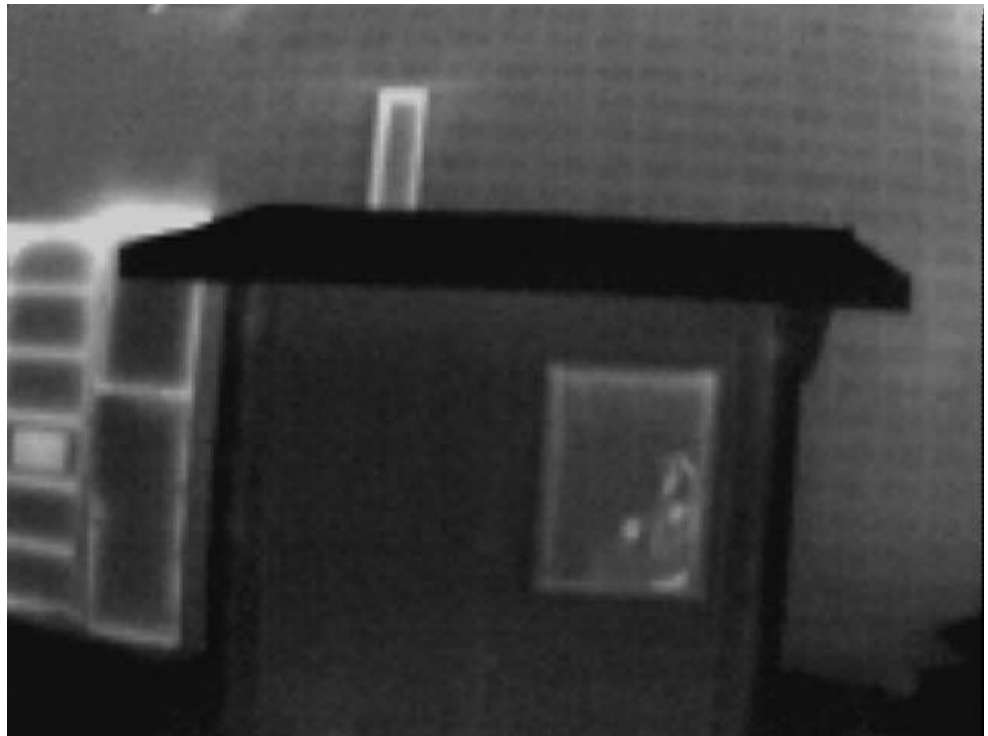
Photo # 7

Picture of the Roof Area of
the test building.

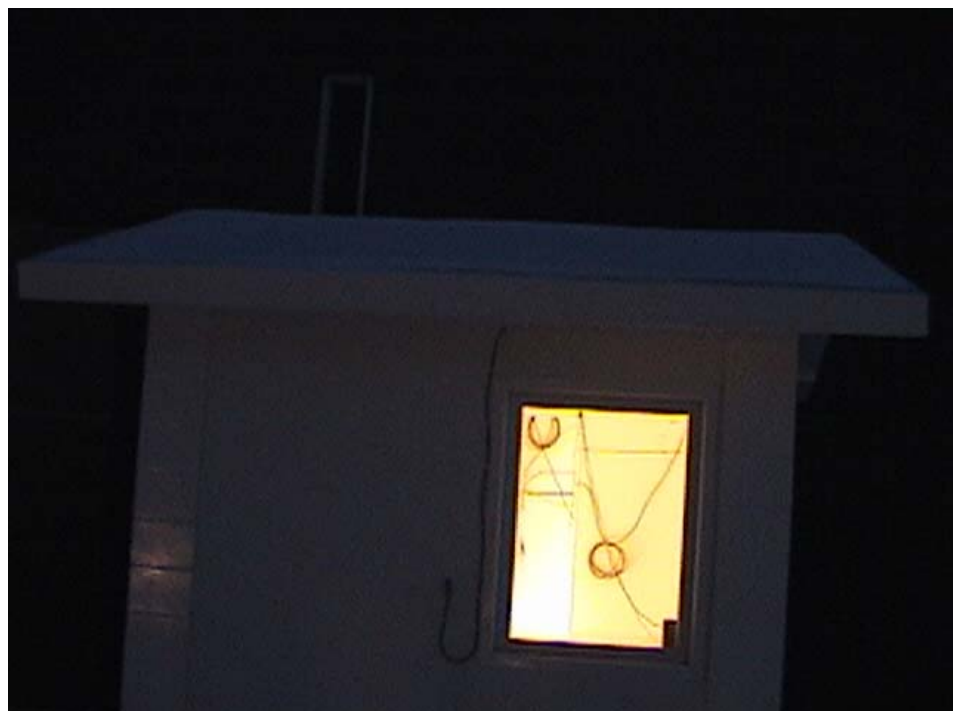
Photo # 8

Real Life photograph of the
test building.

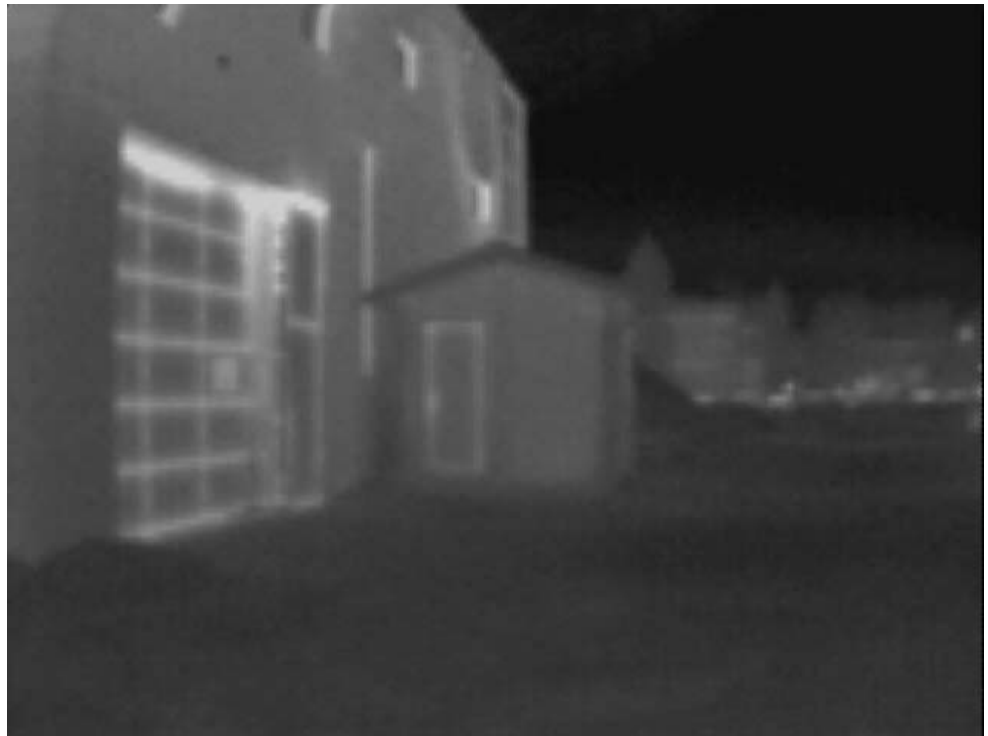
Photo # 9

Overall Picture of the test building.

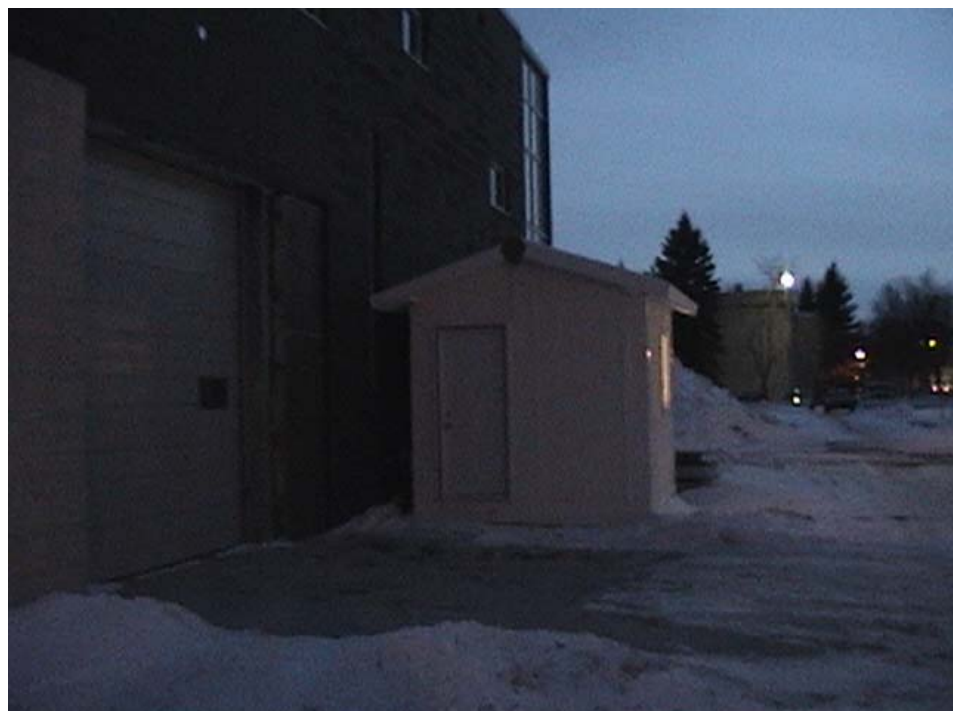
Photo # 10

Real Life photograph of the test building.
